WHAT HAPPENED ON THE DEEPWATER HORIZON

On April 20, Deepwater Horizon was two days away from temporarily capping the oil well it had drilled and handing off the pumping of the oil to a production platform or pipeline. But during this disconnection process the rig suffered a blowout, caught fire and sank to the bottom.

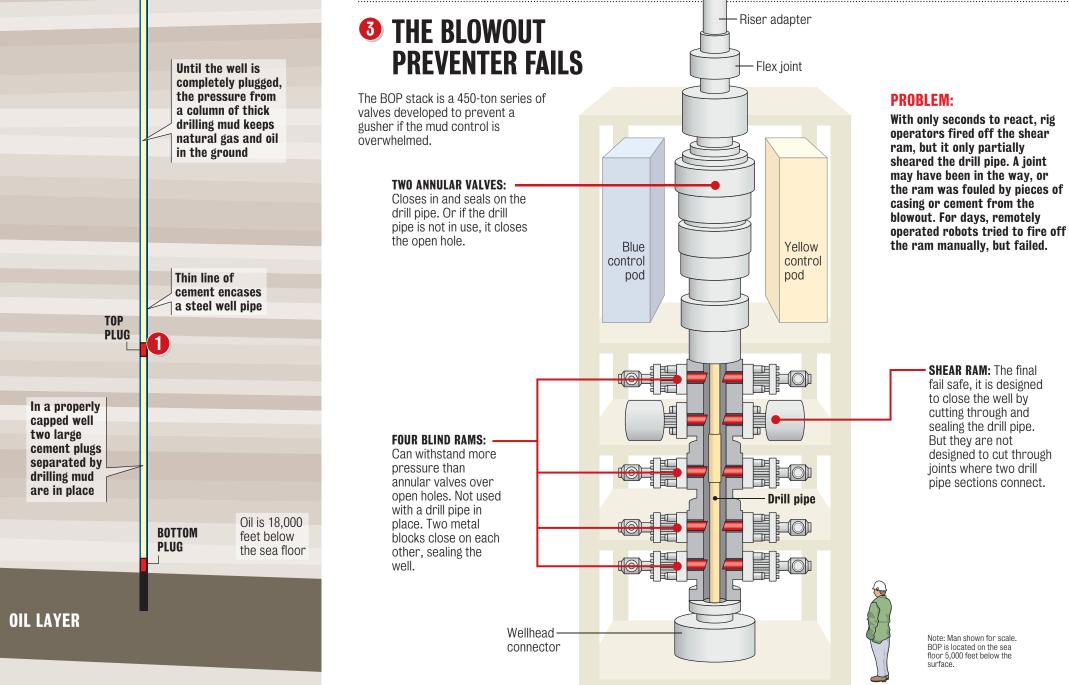
1 THE CEMENT FAILS

Either the primary or secondary cementing failed, pushing a huge column of natural gas into the well pipe.

29 SEAWATER IN THE RISER

When the cement failed, the natural gas rocketed to the surface, as the weakened mixture of mud and seawater did not have the pressure necessary to hold the gas back. The gas exploded the rig, killing 11 men and destroying the rig.
