WHAT HAPPENED ON THE DEEPWATER HORIZON

On April 20, Deepwater Horizon was two days away from temporarily capping the oil well it had drilled and handing off the pumping of the oil to a production platform or pipeline. But during this disconnection process the rig suffered a blowout, caught fire and sank to the bottom.

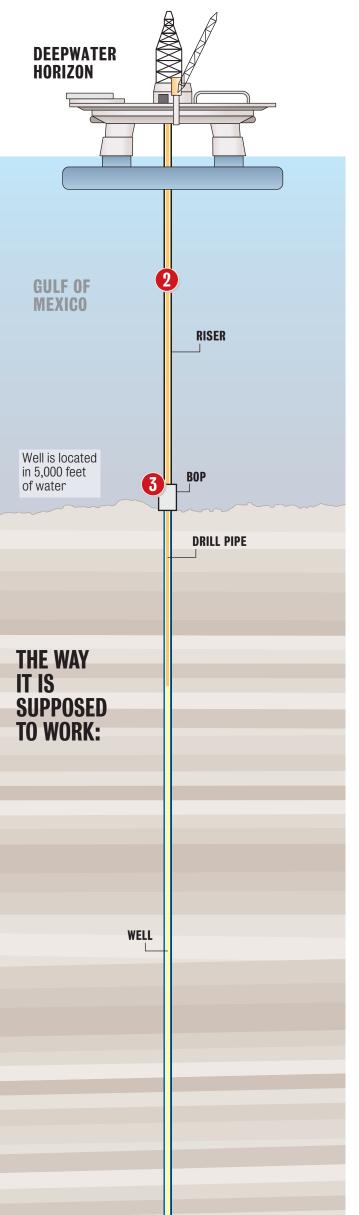
1 THE CEMENT FAILS

Cement is supposed to protect the outside of the well pipe and is used to seal off a well when needed.

Either the primary or secondary cementing failed, pushing a huge column of natural gas into the well pipe.

29 SEAWATER IN THE RISER

Deepwater Horizon had begun to remove the heavy column of drilling mud that is the primary means of controlling pressure inside a well.

When the cement failed, the natural gas rocketed to the surface, as the weakened mixture of mud and seawater did not have the pressure necessary to hold the gas back. The gas exploded the rig, killing 11 men and destroying the rig.

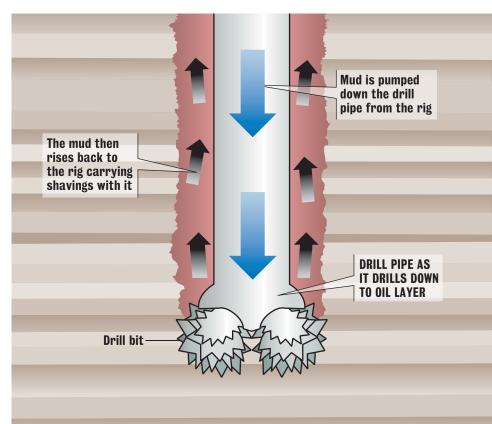
Primary

Cement is pushed between the well casings and the sediment layers that have been drilled through. It protects the metal wall from gas pressure and from gas leaking up the outside of the well pipe.

Secondary

When a well is to be temporarily abandoned, two plugs are cemented in with drilling fluid between them. Sometimes more plugs are used.
